1
Slope Stability Analysis Using the Rock Structure Rating (RSR) Method and Atterberg Limit at Riau - West Sumatra Cross road Km 165 Harau Subdistrict, Lima puluh Kota Regency, West Sumatra Province, Indonesia

Husnul Kausarian^{2*}, Shaury Aldila¹, Batara², Dewandra Bagus Eka Putra¹, Fitri Mairizki¹

Abstract

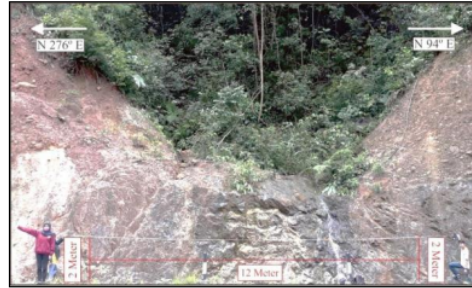
Fig. 3. Measurement Location Scanline 1

Slope on *scanline 1* has a slope length of 12 m and a slope height of 10 m. The lithology is in the form of sandstone on the bottom layer and conglomerate on the top layer. Sandstone with weathered brownish yellow color and fresh whitish yellow color, fine-medium grain size, rounded to moderate angles, good sorting, soft compactness can be crushed. Meanwhile, the conglomerate has a weathered color of yellowish brown and fresh color of whitish brown, the size of the gravel fragments (1-20cm), the shape of the fragments is rounded, open packaging, the compactness is soft-a bit hard. On *scanline 1* it has experienced high weathering, because more than half of the rock has begun to decompose and has a significant discoloration. Discontinuity data on *scanline 1* was in the form of joints/fractures, found 50 joints with the average distance between joints being close, the width of the discontinuity fracture being slightly narrow, and the water conditions being moist. In taking discontinuity data, only one layer area is at the retrieval distance *scanline*. Can be seen in Fig. 3.

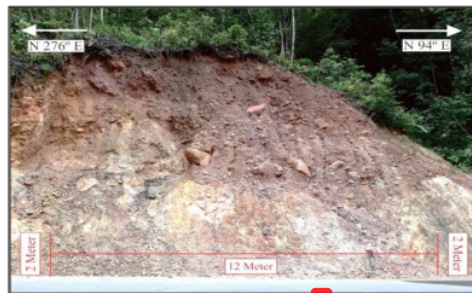
Fig. 4. Measurement Location Scanline 2

Slope on *scanline 2* has a slope length of 12 m with different slope heights, on the left the slope has a height of about 10 m, the middle is 5 m and the right is 8 m. The lithology is in the form of sandstone on the bottom layer and conglomerate on the top layer. Sandstone with brownish-yellow weathered color and blackish-gray fresh color, fine-medium grain size, rounded, well-sorted, hard compact.

Meanwhile, conglomerate has a yellowish brown weathered color and whitish brown fresh color, the size of the fragments is cobble-stoned, the shape of the fragments is rounded, half-rounded, open packaging, hard compactness. On *scanline 2* experienced mild weathering, because the rock experienced discoloration on the damaged aggregate or on the surface of the discontinuity plane. Discontinuity data on *scanline 2* in the form of joints/fractures, found 70 joints with an average spacing between joints being moderate, the width of the discontinuity fracture being slightly narrow, and wet water conditions. In taking discontinuity data, only one layer area is at the retrieval distance *scanline*. Can be seen in Fig. 4.

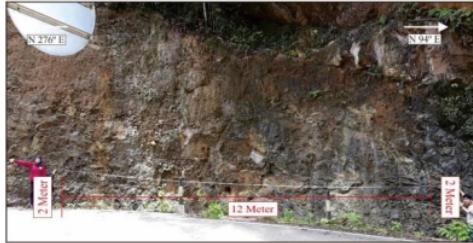
Fig. 5. Measurement Location Scanline 3

Slope on *scanline 3* has a slope length of 12 m and a slope height of 8 m. The lithology is in the form of sandstone on the bottom layer and conglomerate on the top layer. Sandstone with brownish-yellow weathered color and blackish-gray fresh color, fine-medium grain size, rounded, well-sorted, hard compact. Meanwhile, the conglomerate has a weathered color of yellowish brown and fresh color of whitish brown, the size of the gravel-barky fragments, the shape of the fragments is rounded, open packaging, the compactness is rather loud. On *scanline 3* experienced light weathering. Discontinuity data on *scanline 3* in the form of joints/fractures, found 80 joints with an average spacing between joints being moderate, the width of the discontinuity fracture being slightly narrow, and wet water conditions. In taking discontinuity data, only one layer area is at the retrieval distance *scanline*. Can be seen in Fig. 5.

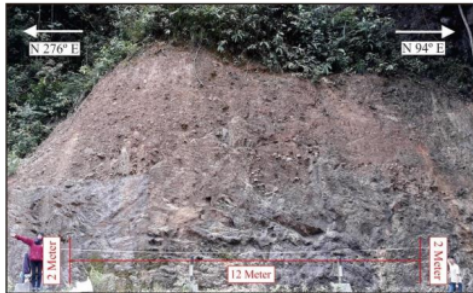
Fig. 6. Measurement Location Scanline 4

Slope on *scanline 4* has a slope length of 12 m and a slope height of 8 m. The lithology is in the form of sandstone on the bottom layer and conglomerate on the top layer.

1 Sandstone with brownish-yellow weathered color and blackish-gray fresh color, fine-medium grain size, rounded, well-sorted, hard compact. Meanwhile, the conglomerate has a weathered color of yellowish brown and fresh color of whitish brown, the size of the gravel-barky fragments, the shape of the fragments is rounded, open packaging, the compactness is rather loud. Discontinuity data on scanline 4 in the form of joints/fractures, found 70 joints with the average distance between joints being close, the width of the discontinuity fracture being slightly narrow and the water conditions being moist. Scanline 3 experiences mild weathering, because the rock changes color on the damaged aggregate or discontinuity surface. In taking discontinuity data, only one layer area is at the retrieval distance scanline. Can be seen in Fig. 6.

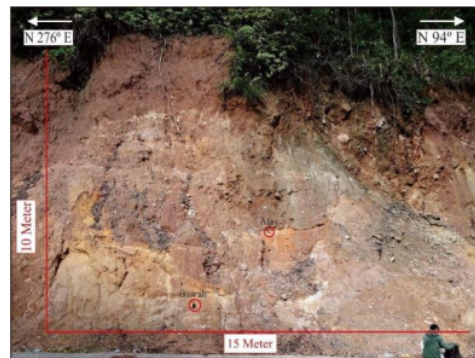
Fig. 9. Soil Sampling Research Slope

Research slopes that experience high weathering thus some of the rock material has become soil is used as a sample used to carry out sieve analysis (sieve analysis). The research slope is 15 meters long and 10 meters high. The soil sample used for sieve analysis was divided into two parts, namely the upper and lower parts. Can be seen in Fig. 9.

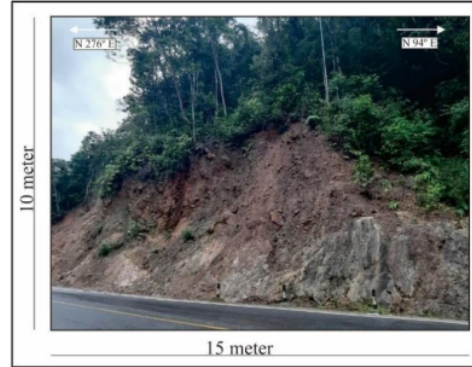
Fig. 14. RSR Research Slope Part 1

The slope of part 1 in the analysis of the RSR method has a slope length of 15 meters and a slope height of 10 meters (Fig. 14). Has a high level of weathering with sandstone and conglomerate lithology. In parameter A, it is known that the type of rock is weathered sediment with type 4 and there is a geological structure in this study, namely intensive folding or fracture with a rating of 6 (Table 16).

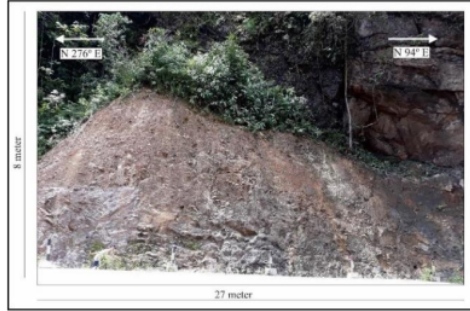
Fig. 17. RSR Research Slope Part 3

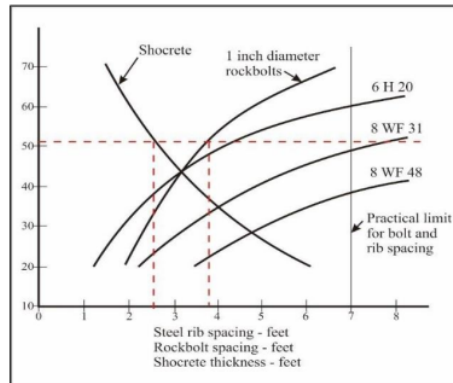
Fig. 18. Slope RSR Graph Part 3

The rating for each parameter is added up and the RSR value is obtained, the RSR value on slope part 3 is 51. Then this value is plotted on the RSR graph. It can be seen on the graph treatment or support on the slope of section 3, namely giving rockbolts and shotcrete. Rockbolts used in the Rock Structure Rating (RSR) method that is 1 inch in diameter, with a space between rock bolts which is 3.8 feet. Then spraying the shotcrete on the slope with a thickness of 2.6 inches. Can be seen in Fig. 18.

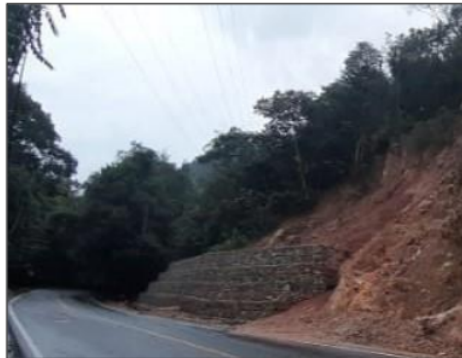
Fig. 23. Landslide Mitigation with Retaining Rock Embankments

The condition of the research slope on the left side of the slope has experienced landslides. In the landslide section, it can be seen that the rocks on the inside of the slope have experienced weathering and tend to move toward the soil. Mitigation that can be given to the slopes that have experienced landslides is different from the rock slope conditions studied. One example of mitigation given to slopes that have experienced landslides is the construction of rock embankments to resist landslides. Can be seen in Fig. 23.
