RESEARCH ARTICLE

Slope Stability Analysis Using the Rock Structure Rating (RSR) Method and Atterberg Limit at Riau - West Sumatra Cross road Km 165 Harau Subdistrict, Lima puluh Kota Regency, West Sumatra Province, Indonesia

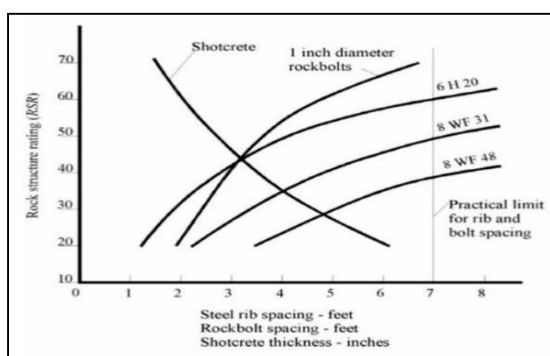
Fig 2. Diagram RSR (Wickham, 1972)

After obtaining the values of parameters A, B and C, then these values are added up to get the RSR value. The values obtained are then plotted on the RSR diagram, thus support can be identified (treatment) to be assigned to the slope.

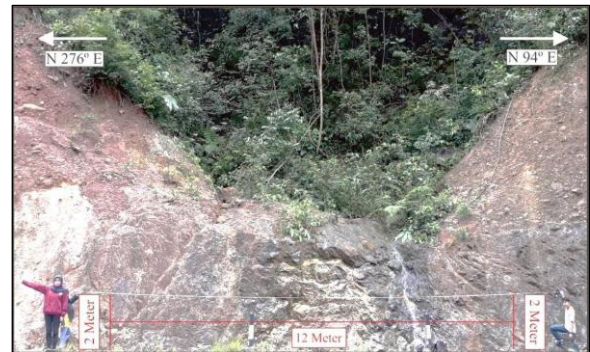
Fig. 3. Measurement Location Scanline 1

Slope on scanline 1 has a slope length of 12 m and a slope height of 10 m. The lithology is in the form of sandstone on the bottom layer and conglomerate on the top layer. Sandstone with weathered brownish yellow color and fresh whitish yellow color, fine-medium grain size, rounded to moderate angles, good sorting, soft compactness can be crushed. Meanwhile, the conglomerate has a weathered color of yellowish brown and fresh color of whitish brown, the size of the gravel fragments (1-20cm), the shape of the fragments is rounded, open packaging, the compactness is soft-a bit hard. On scanline 1 has experienced high weathering, because more than half of the rock has begun to decompose and has a significant discoloration. Discontinuity data on scanline 1 was in the form of joints/fractures, found 50 joints with the average distance between joints being close, the width of the discontinuity fracture being slightly narrow, and the water conditions being moist. In taking discontinuity data, only one layer area is at the retrieval distance scanline. Can be seen in Fig. 3.

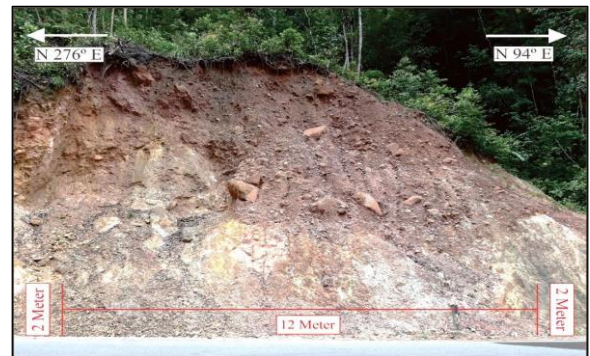
Fig. 4. Measurement Location Scanline 2

Slope on scanline 2 has a slope length of 12 m with different slope heights, on the left the slope has a height of about 10 m, the middle is 5 m and the right is 8 m. The lithology is in the form of sandstone on the bottom layer and conglomerate on the top layer. Sandstone with brownish-yellow weathered color and blackish-gray fresh color, fine-medium grain size, rounded, well-sorted, hard compact.

Meanwhile, conglomerate has a yellowish brown weathered color and whitish brown fresh color, the size of the fragments is cobble-stoned, the shape of the fragments is rounded, half-rounded, open packaging, hard compactness. On scanline 2 experienced mild weathering, because the rock experienced discoloration on the damaged aggregate or on the surface of the discontinuity plane. Discontinuity data on scanline 2 in the form of joints/fractures, found 70 joints with an average spacing between joints being moderate, the width of the discontinuity fracture being slightly narrow, and wet water conditions. In taking discontinuity data, only one layer area is at the retrieval distance scanline. Can be seen in Fig. 4.

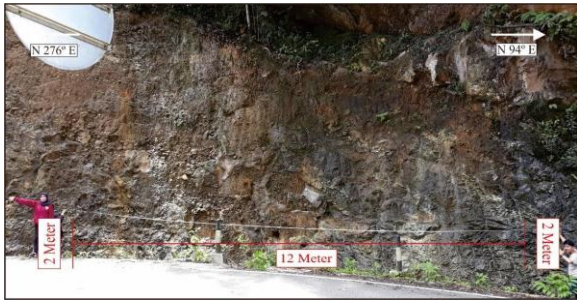
Fig. 5. Measurement Location Scanline 3

Slope on scanline 3 has a slope length of 12 m and a slope height of 8 m. The lithology is in the form of sandstone on the bottom layer and conglomerate on the top layer. Sandstone with brownish-yellow weathered color and blackish-gray fresh color, fine-medium grain size, rounded, well-sorted, hard compact. Meanwhile, the conglomerate has a weathered color of yellowish brown and fresh color of whitish brown, the size of the gravel-barky fragments, the shape of the fragments is rounded, open packaging, the compactness is rather loud. On scanline 3 experienced light weathering. Discontinuity data on scanline 3 in the form of joints/fractures, found 80 joints with an average spacing between joints being moderate, the width of the discontinuity fracture being slightly narrow, and wet water conditions. In taking discontinuity data, only one layer area is at the retrieval distance scanline. Can be seen in Fig. 5.

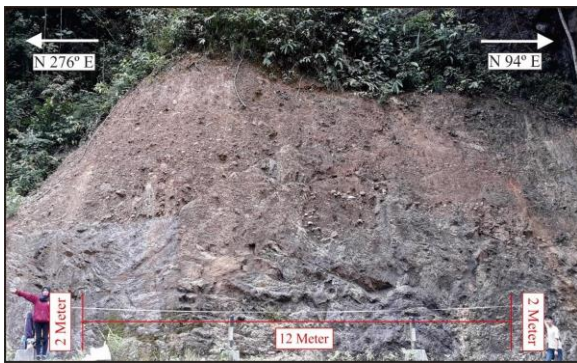
Fig. 6. Measurement Location Scanline 4

Slope on scanline 4 has a slope length of 12 m and a slope height of 8 m. The lithology is in the form of sandstone on the bottom layer and conglomerate on the top layer.

Sandstone with brownish-yellow weathered color and blackish-gray fresh color, fine-medium grain size, rounded, well-sorted, hard compact. Meanwhile, the conglomerate has a weathered color of yellowish brown and fresh color of whitish brown, the size of the gravel-barky fragments, the shape of the fragments is rounded, open packaging, the compactness is rather loud. Discontinuity data on scanline 4 in the form of joints/fractures, found 70 joints with the average distance between joints being close, the width of the discontinuity fracture being slightly narrow and the water conditions being moist. Scanline 3 experiences mild weathering, because the rock changes color on the damaged aggregate or discontinuity surface. In taking discontinuity data, only one layer area is at the retrieval distance scanline. Can be seen in Fig. 6.

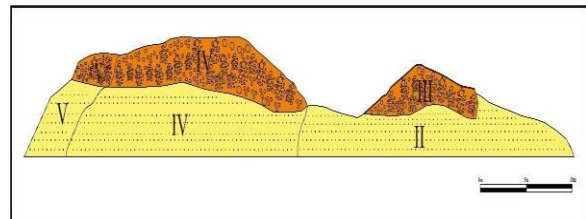
Fig. 8. Sketch of Research Slope Weathering Rate

1. Weathering level II (Lightly Weathered): Sandstones on slopes that have weathering level II are characterized by changes in the color of the rock material in the field, fractures are covered with flow fill material in the form of clay which is not yet significant, there are no sand grains on the slopes, only color changes occur.

3. Weathering level IV (High Weathered): Sandstones and conglomerates on slopes that have weathering level IV are characterized by contrasting color changes and there is already a lot of sand or highly decomposed material, more than 35% of the conditions in the area have changed to

4. Weathering level V (Perfectly Weathered): Sandstones and conglomerates on slopes that have weathering level V are characterized by all material having been decomposed into soil, but the original mass structure is partially intact and some of the sides of the slope have experienced landslides.

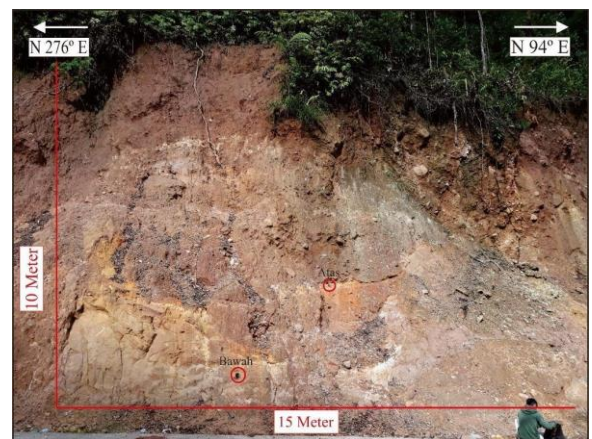
Fig. 9. Soil Sampling Research Slope

Research slopes that experience high weathering thus some of the rock material has become soil is used as a sample used to carry out sieve analysis (sieve analysis). The research slope is 15 meters long and 10 meters high. The soil sample used for sieve analysis was divided into two parts, namely the upper and lower parts. Can be seen in Fig. 9.

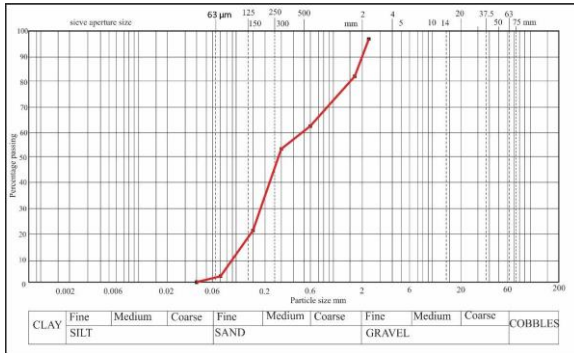
Fig. 10. Graph of Soil Sample Sieve Analysis at the Bottom

After obtaining the values from the sieve analysis results in Table 7, then these values are plotted into the sieve analysis diagram Fig. 10 to determine the grain distribution of the soil sample. The values plotted into the sieve analysis diagram are the % Finer values and the sieve size.

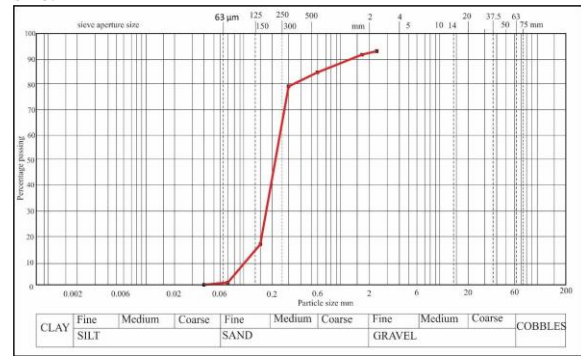
Fig. 11. Graph of Soil Sample Sieve Analysis at the Top

After obtaining the values from the sieve analysis results in Table 9, then these values are plotted onto the sieve analysis diagram in Fig. 11 to determine the grain distribution of the soil sample. The values plotted in the

Based on the graph in Fig.11, it can be concluded that in the soil samples at the top of the slope, the grain size distribution from the smallest silt to the largest grain size is coarse sand and the value $Cu = 2.3$ means the soil grains are uniform, the value $Cz = 1.3$ means the soil is poorly graded. Poorly graded soils are soils that have a grain size that is not evenly distributed from large to small grain sizes. And the value of $So = 1.28$ means good sorting or sorting with uniform grain sizes (Table 10).

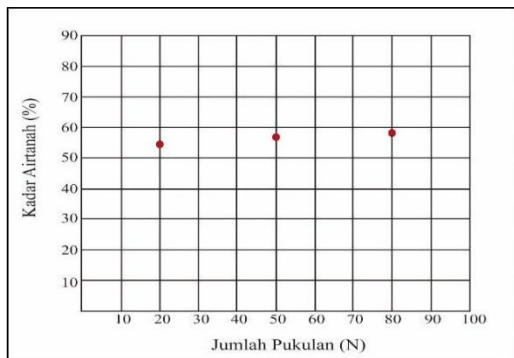
Fig. 12. Test Graph *Liquid Limit* Soil Samples at the Bottom

After obtaining the calculated value liquid limit, then the data on the number of blows and groundwater content is plotted onto the graph. Can be seen in Fig. 12.

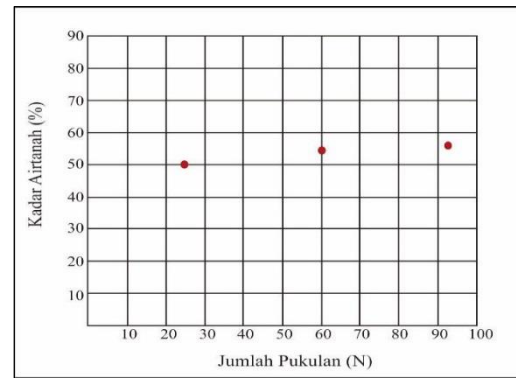
Fig. 12. Test Graph *Liquid Limit* Soil Samples at the Top

The conclusion from the liquid limit test of 2 soil samples obtained different values. The lower slope has a value of 38.8% and the upper slope has a value of 15.01%. From the analysis results, it is because the different water content causes each experiment to have a different number of strokes, the less water content in the sample, the greater

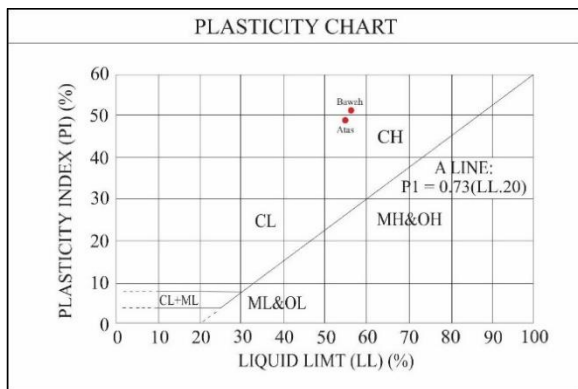
Fig. 13. Graph Plasticity Index of Soil Samples

Then the results of calculating the plasticity index are plotted onto a graph (Fig. 13), to determine the soil classification in the study area.

Based on the Atterberg Limit analysis results, soil samples were obtained from two parts of the lower and upper slopes, namely CH (Clay High Plasticity), an inorganic clay with high plasticity. From the sample analysis, it is known that clay with high plasticity can result in slope failure or landslides because clay is capable of absorbing/storing water but cannot allow water to pass through. With the condition of high water content, the strength of the soil is getting worse, which triggers landslides. The purpose of high plasticity soil is soil that has high swelling and shrinkage of the soil, thus if the range of water content in the soil is higher, the strength of the soil will be low or poor.

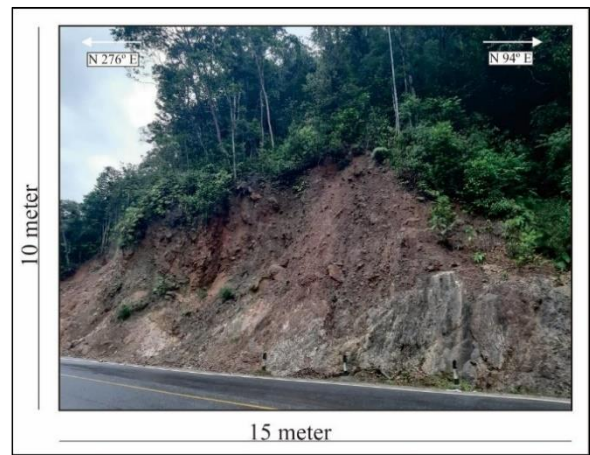
Fig. 14. RSR Research Slope Part 1

The slope of part 1 in the analysis of the RSR method has a slope length of 15 meters and a slope height of 10 meters (Fig. 14). Has a high level of weathering with sandstone and conglomerate lithology. In parameter A, it is known that the type of rock is weathered sediment with type 4 and there is a geological structure in this study, namely intensive folding or fracture with a rating of 6 (Table 16).

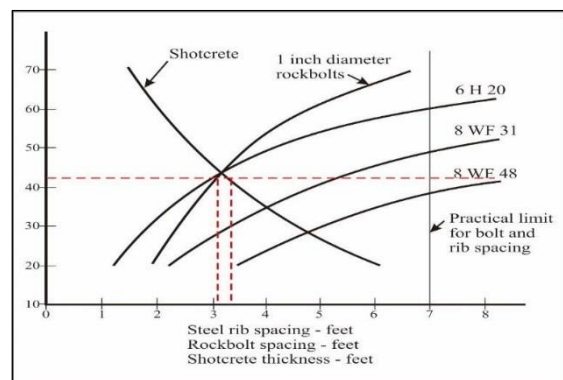
Fig. 15. Slope RSR Graph Part 1

The RSR value on slope part 1 is 43. Then this value is plotted on the RSR graph. It can be seen on the graph treatment or support on the slope part 1, namely giving rockbolts and shotcrete. Rockbolts used in the Rock

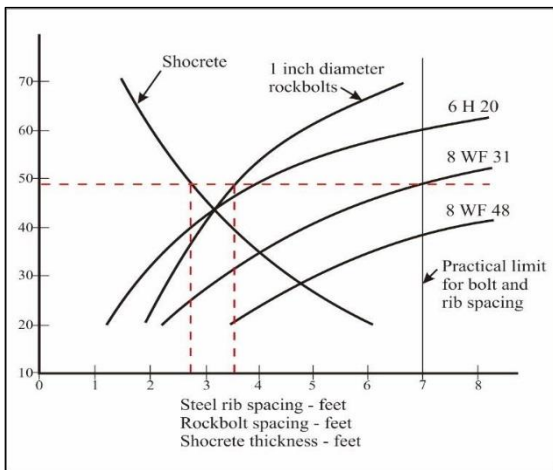
Fig. 16. Slope RSR Graph Part 2

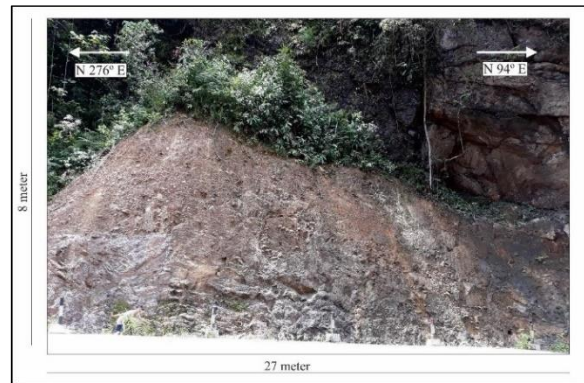
Fig. 17. RSR Research Slope Part 3

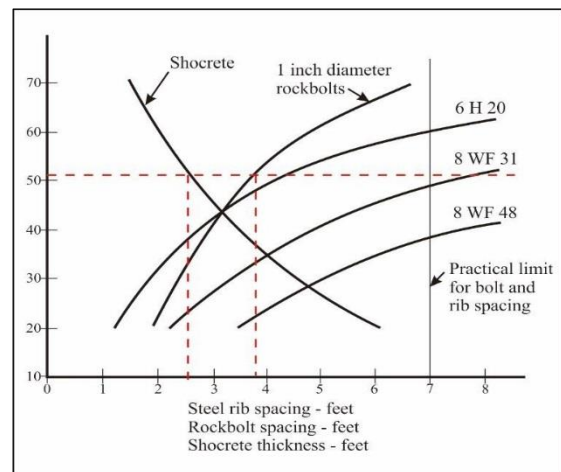
Fig. 18. Slope RSR Graph Part 3

The rating for each parameter is added up and the RSR value is obtained, the RSR value on slope part 3 is 51. Then this value is plotted on the RSR graph. It can be seen on the graph treatment or support on the slope of section 3, namely giving rockbolts and shotcrete. Rockbolts used in the Rock Structure Rating (RSR) method that is 1 inch in diameter, with a space between rock bolts which is 3.8 feet. Then spraying the shotcrete on the slope with a thickness of 2.6 inches. Can be seen in Fig. 18.

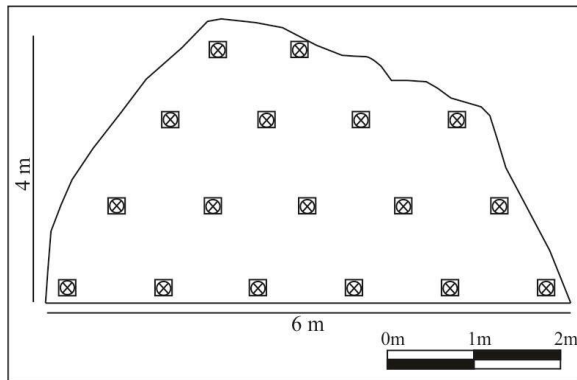
Fig. 19. Sketch illustration *Rock shop* 1 inch in diameter 3.1 feet apart on slope section 1

Part 1 of the slope is 15 m long and 10 m high with high weathering conditions. Based on the RSR value obtained, it is known treatment that can be done is planting rockbolts with spacing rockbolts 3.1 feet than in terms of horizontal totaling 16 rockbolts in one line, whereas in vertical totaling 11 rockbolts in one line (Fig. 19). Then spraying shotcrete on a slope with a thickness of 3.3 inches or 83.8 mm (Fig. 20).

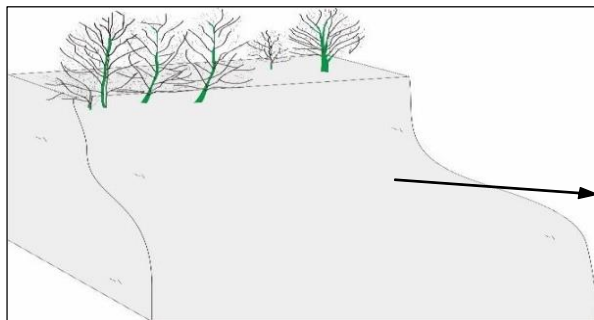
Fig. 20. Sketch illustration Shotcrete with a Thickness of 3.3 inches On Slope Section 1

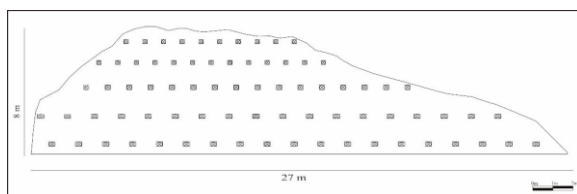
Fig. 21. Sketch illustration *Rock shop* 1 Inch Diameter 3.5 ft Spacing On Section 2 Slope

Section 2 slope has a length of 6 m and a height of 4 m with mild weathering conditions. Based on the RSR value obtained, it is known that the treatment that can be carried out is planting rockbolts with a distance of 3.5 feet between the rockbolts, thus horizontally there are 6 rockbolts in one row, while vertically there are 4 rockbolts in one row (Fig. 21). Then spraying the shotcrete on a slope with a thickness of 2.7 inches or 68.5 mm (Fig. 22).

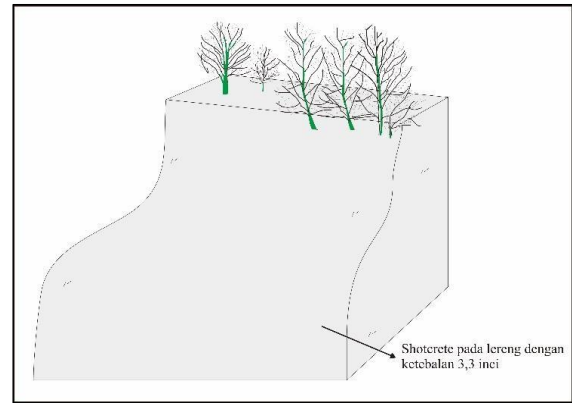
Fig. 22. Sketch illustration *Shotcrete* with a Thickness of 2.7 inches On Section 2 Slope

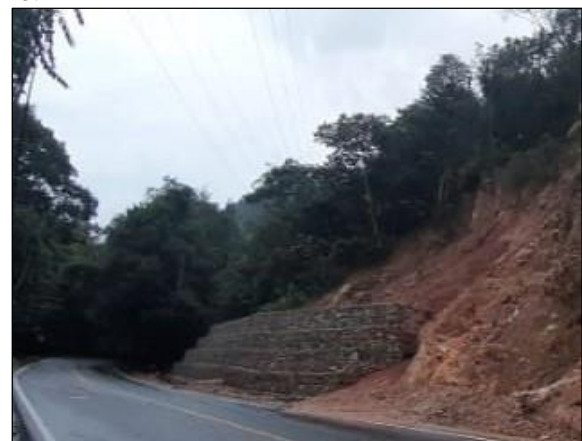
Fig. 23. Landslide Mitigation with Retaining Rock Embankments

The condition of the research slope on the left side of the slope has experienced landslides. In the landslide section, it can be seen that the rocks on the inside of the slope have experienced weathering and tend to move toward the soil. Mitigation that can be given to the slopes that have experienced landslides is different from the rock slope conditions studied. One example of mitigation given to slopes that have experienced landslides is the construction of rock embankments to resist landslides. Can be seen in Fig. 23.
