Application of a Comprehensive Rock Slope Stability Assessment Approach for Selected Malaysian Granitic Rock Slopes (Pengaplikasian Pendekatan Penilaian Kestabilan Cerun Batu Komprehensif untuk Cerun Batu Granit Malaysia yang Terpilih)

ABSTRACT

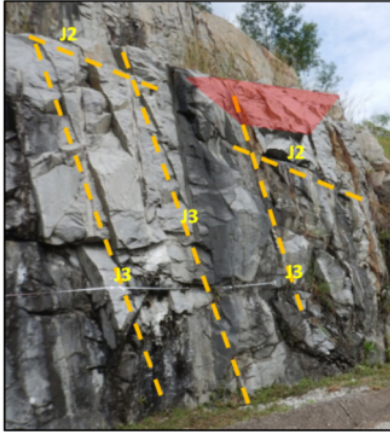
Slope LHA with multiple discontinuities sets, generally exhibit blocky nature, but no major failure observed.

Planar J2, Wedges J1*J2, J2*J3, J2*J5, and J3*J5.

RMR_{basic}: 71, Lowest SMR rating at 17 (Class V) due to potential planar failure J2. Failed block from planar failure is shown as red area.

No major large-scaled potential planar or wedge failures observed on site. The identified potential failures are small-sized blocks that may contribute to rock falls. (Multiple fallen blocks at the foot of slope).

Scaling on loose blocks, rock ditch with barrier at bottom of slope to capture rock falls.
